Stamped Structural Inspection Report

Inspection Date	12-16-2024
Inspection Address	Pet Smart Parma, OH

Item 1:	The purpose was to document the structural cracks in the masonry walls, and to gauge the life-safety risk. This also serves to guide the appropriate plan of action moving forward.
---------	---

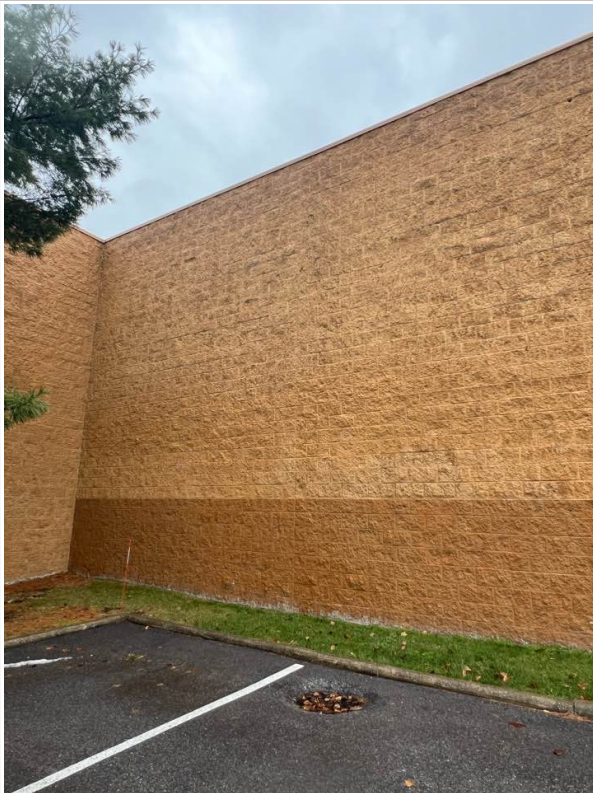
Item 1:	Here is a view of the exterior masonry wall. This is the location of where the joist girder is pulling away from the wall on the inside.

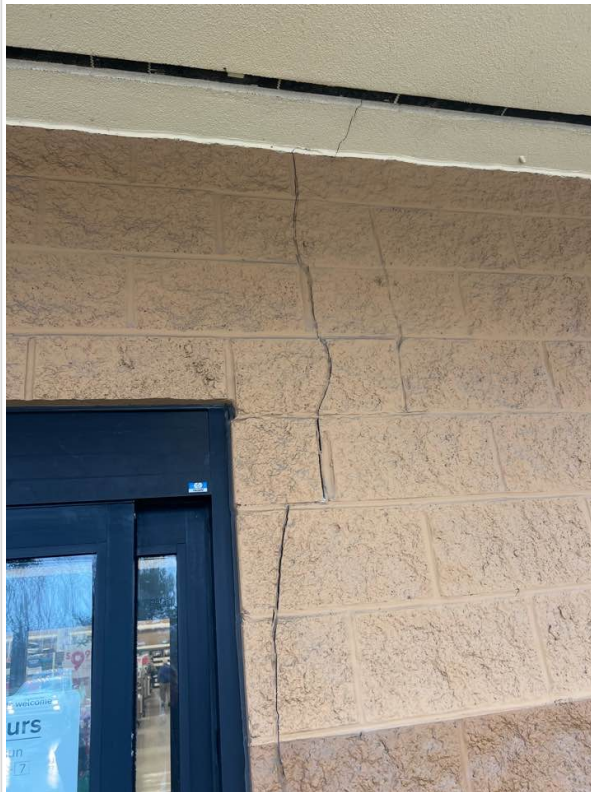
Item 3:	<p>Here is a view of an exterior hairline crack. This doesn't present a structural concern because the walls are fully reinforced with vertical rebar and horizontal bond beams. Typically they use #5 rebar in walls like this. This is more than sufficient to hold the masonry together, even with minor hairline cracks.</p>
Single Photo

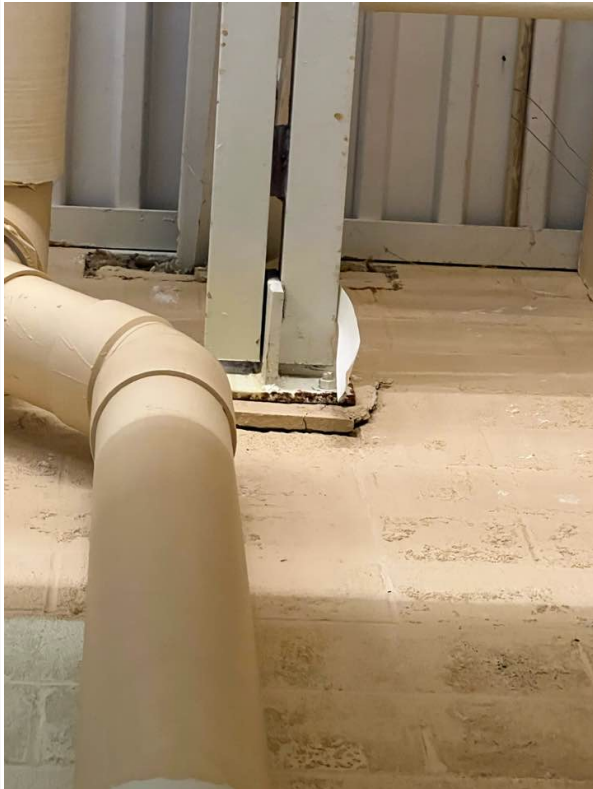
Item 4:	<p>Here is the view of the shears bottom cord connection at the interior of the masonry block wall.</p>

Long Text	<p>The minor and limited hairline cracks do not present a concern. However the joist girder bottom cord sheared connection does present a structural concern. This must be repair. This will require a stamped engineered repair drawings. Cramer Engineering can provide a stamped repair drawing right away for \$5,000. Please let us know if this is acceptable. Cramer Engineering will then assume all responsibility and liability. This includes all meetings, revisions and no hidden fees. Thank you very kindly.</p> <p>Respectfully,</p>
Inspection and Report By:	James Cramer, P.E.
Report Reviewed By:	James Cramer, P.E.
Embedded Photo

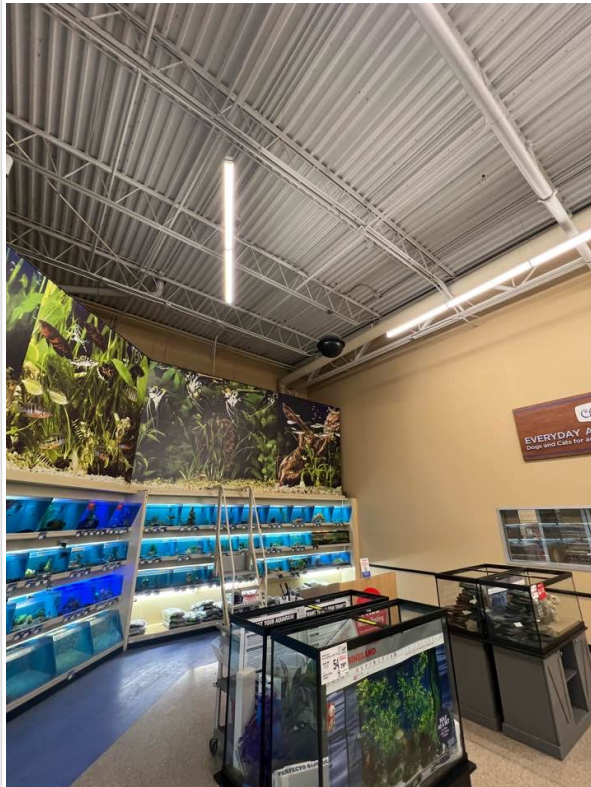
Item 6:

This is the area where this occurs.
